6150 and Garmin: Dispatch and Navigation

The Contigo 6150 provides a fleet management interface to Garmin™ Personal Navigation Devices (PNDs) including the nüvi® 2x5, 465, 12xx, 13xx, and 14xx series. The 6150 may be connected to Garmin PNDs via a custom wiring harness that supports Dispatch and Navigation in addition to all existing Contigo functions. From the Contigo web application, Dispatchers may send jobs and messages to vehicles, and monitor the status of jobs as drivers accept their jobs on the PND. Drivers may navigate to the destination and complete these jobs.

This document is an addendum to the 6150 Installation Guide, and describes the additional steps to install the Garmin unit and connect its related wiring to the 6150 and vehicle.

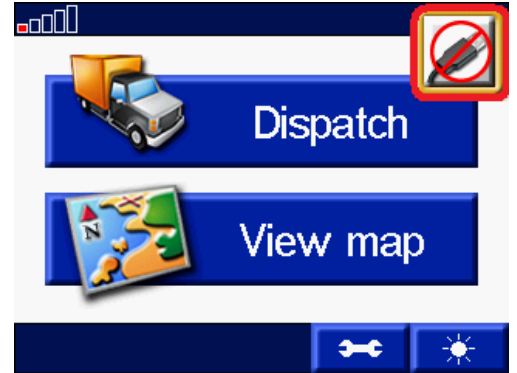
The Garmin shows that the data cable is disconnected.

2. Ensure the data cable is firmly inserted into the mini USB data port (usually on the back of the unit).
3. Ensure the data cable is still connected to the 6150 harness. If not, a replacement harness may be required.

6. Power off the Garmin unit.
7. Disconnect the data/power cable from the Garmin PND.
8. **Wait a minimum of 30 seconds.**
9. Reconnect the data/power cable to the Garmin PND.

10. Turn on the Garmin PND.
